RADIOGRAF RÅDET | 46. ÅRGANG | NR. 08 | OKTOBER 2018

# MRI SAFETY IN COMMON DENTAL MATERIALS

## – WHAT A RADIOGRAPHER NEEDS TO KNOW

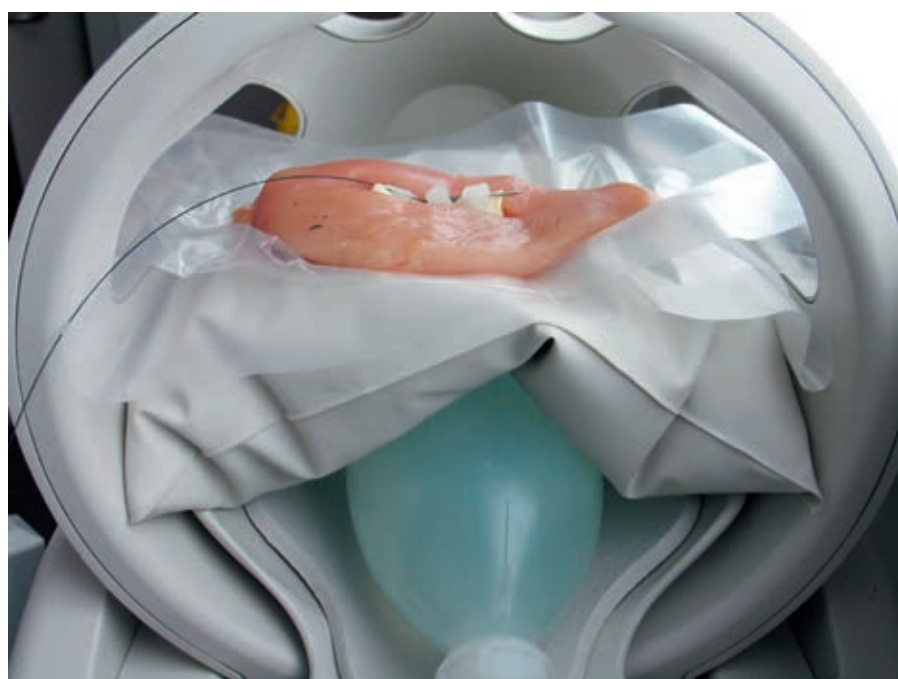
Shows the chicken breast phantom with a dental object placed directly on a dry human finger bone specimen. The phantom was fixed, and placed in the head coil of the scanner.

Radiofrequency heating in dental objects was measured with a fibre optic probe thermometer (LumaSense™ Technologies, Frankfurt, Germany) attached directly to each dental object, during the MRI scans. All the dental objects were placed directly on a dry human finger bone specimen embedded in a large chicken breast phantom. The phantom was fixed, and placed in the head coil of the scanner (Figure 1). The phantom temperature was constant during the scans. All the dental objects were subjected to two MRI sequences. The total scan time for each dental object was 13 minutes and 43 seconds.

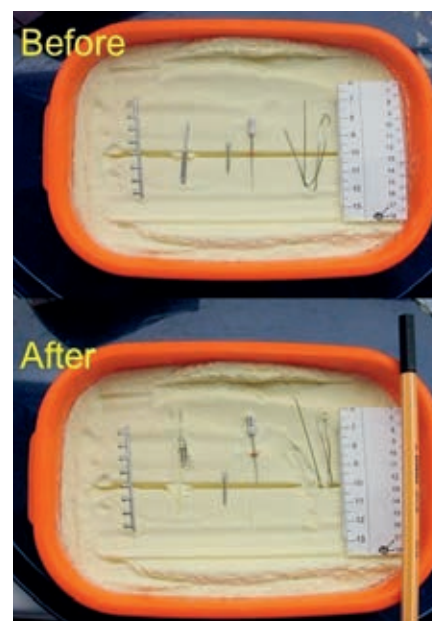
Shows metallic dental objects before and after they had been placed in the centre of the MRI scanner. Notice three dental objects had a weak magnetic attraction force, as they showed physical movement in the flour tray (dental object no. 13, 16, and 21).

A total of three metallic dental objects had a weak magnetic attraction force as they showed physical movement in the flour tray, when bringing the tray in and out of the magnet (dental object no. 13, 16, and 21). The after situation indicated by a pen on the tray (Figure 4).
